**SOLEBURY FARM DAM**

**PHASE I INSPECTION REPORT.**

**NATIONAL DAM INSPECTION PROGRAM**

FEBRUARY 1981

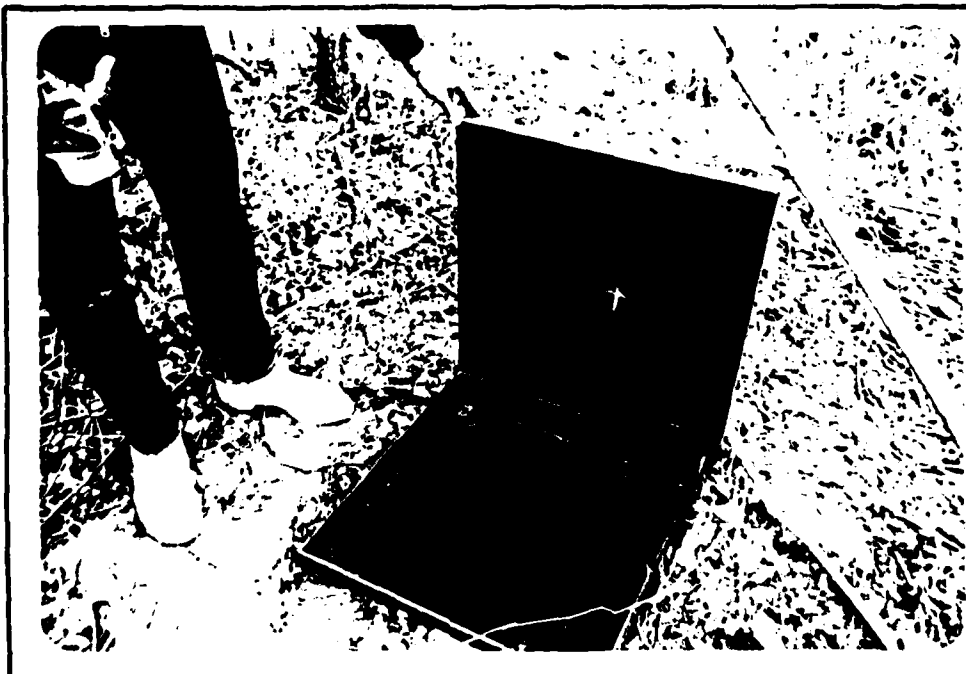
The intake for the reservoir drain is submerged and could not be observed. The access manhole to the valve chamber is located in the dam crest and is covered by a steel plate. The stone masonry manhole, about 25 feet deep, needs pointing. Due to the unknown condition of the ladder rungs set in the masonry wall, an inspection was

not made of the 20-inch diameter control valve located at the bottom of the manhole. It is not known if the valve is operational. A steel pipe is located in the manhole which is apparently used to operate the gate mechanism from the dam crest. The outlet of the reservoir drain pipe is partially submerged. No observations could be made on the condition of the pipe.

The masonry wall and manhole appear to need pointing and the condition of the ladder rungs set in the masonry wall of the manhole is unknown. According to the Owner's representative, it is not known if the control valve on the reservoir drain is operable.

2. MANHOLE ACCESS TO RESERVOIR DRAIN VALVE CONTROL. (12/15/80)

5. Riprap should be placed on the upstream face of the dam to protect the embankment from wave action.
  6. The masonry retaining wall and access manhole should be repointed to limit deterioration. The ladder rungs in the manhole should be inspected and repaired if necessary.
